WATER MANAGEMENT CASE STUDY

Company: Hanson – Heidelberg Cement
Location: La Rinconada – Seville, Spain
Type of site: Sand and gravel pit

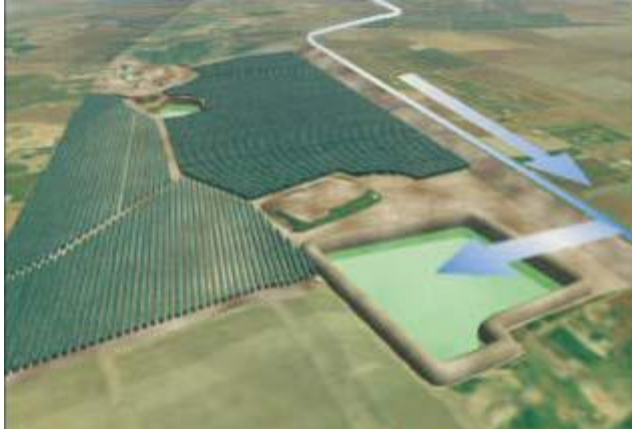
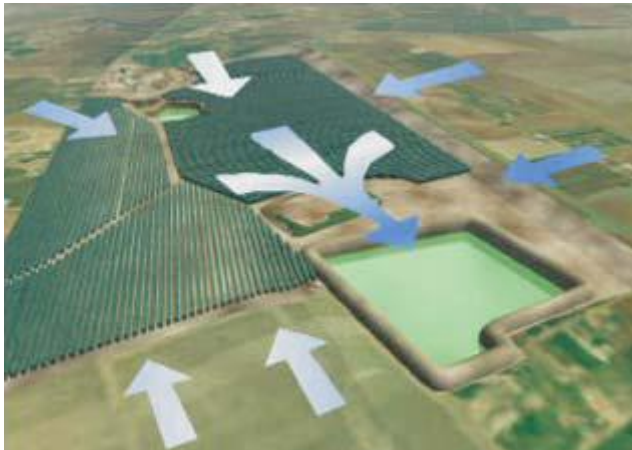
Surface water collection system and irrigation pond (1.000.000 m3) construction. The pond collects by gravity not only surface water from the site and surroundings, but also from Guadalquivir river water floods.
